# Debris/Ice/TPS Assessment And Integrated Photographic Analysis For Shuttle Mission STS-46

September 1992

DEBRIS/ICE/TPS ASSESSMENT  
AND  
PHOTOGRAPHIC ANALYSIS  
OF  
SHUTTLE MISSION STS-46

July 31, 1992

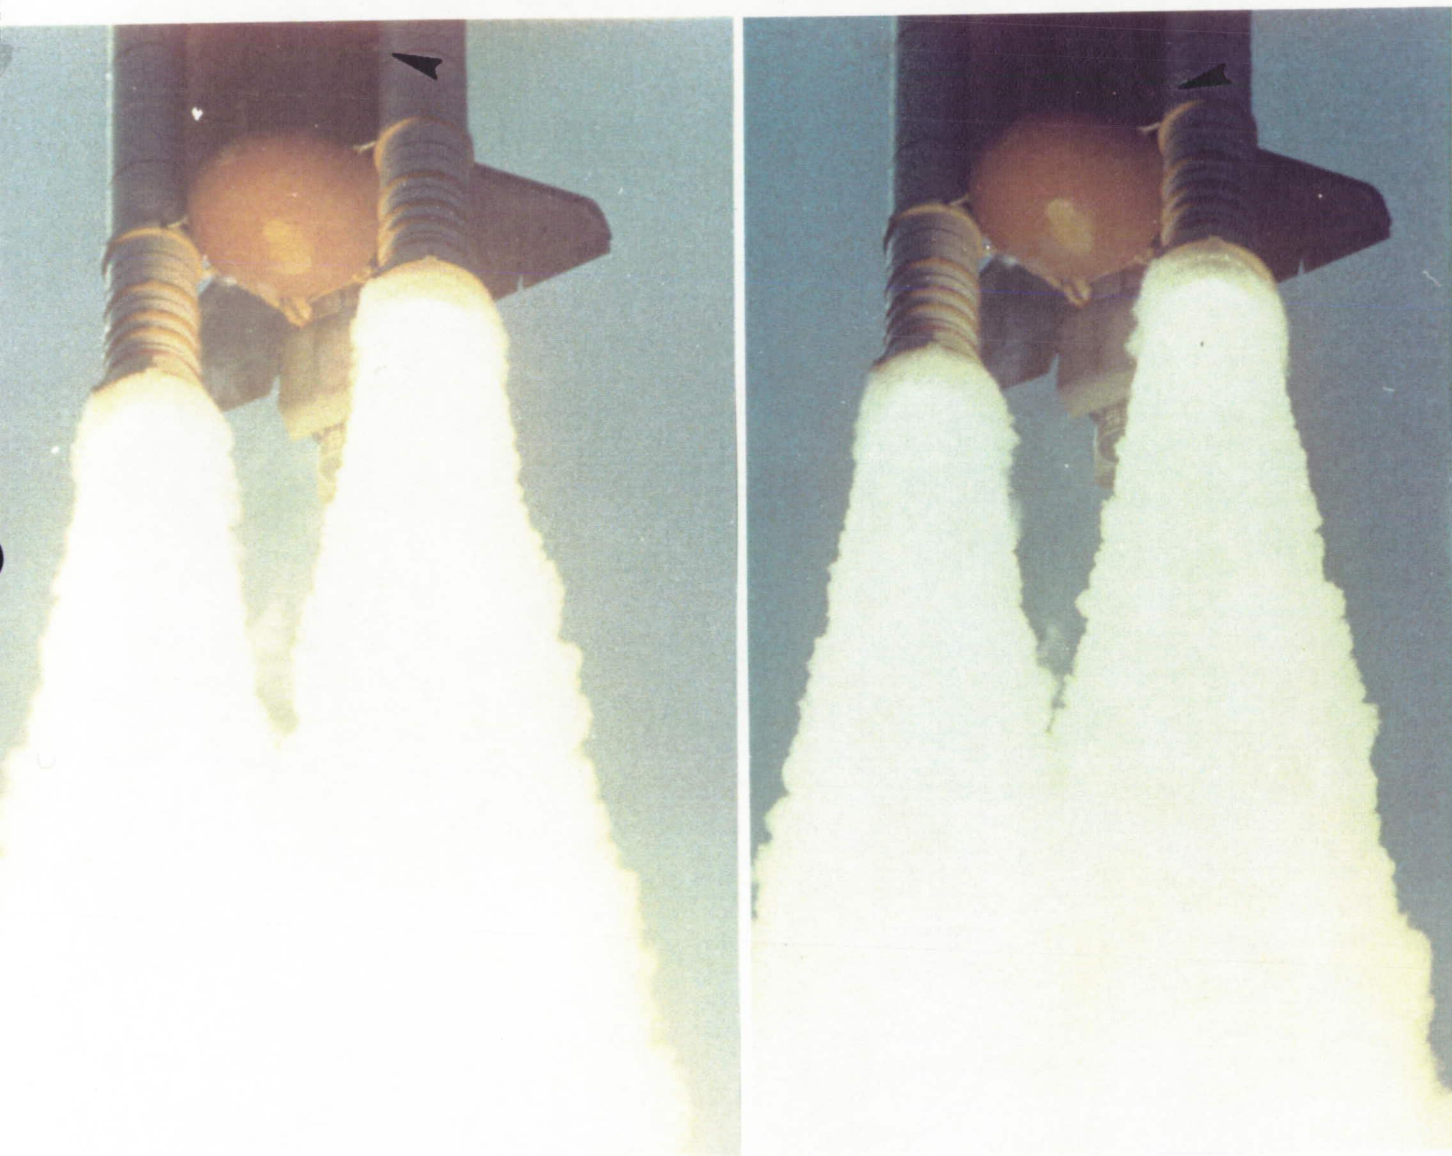
A light-colored, soft focused object first appeared against the LH SRB case and fell aft along the -Z side of the External Tank at 56:59.012 GMT in film item E-57. The origin of the object had not been determine.

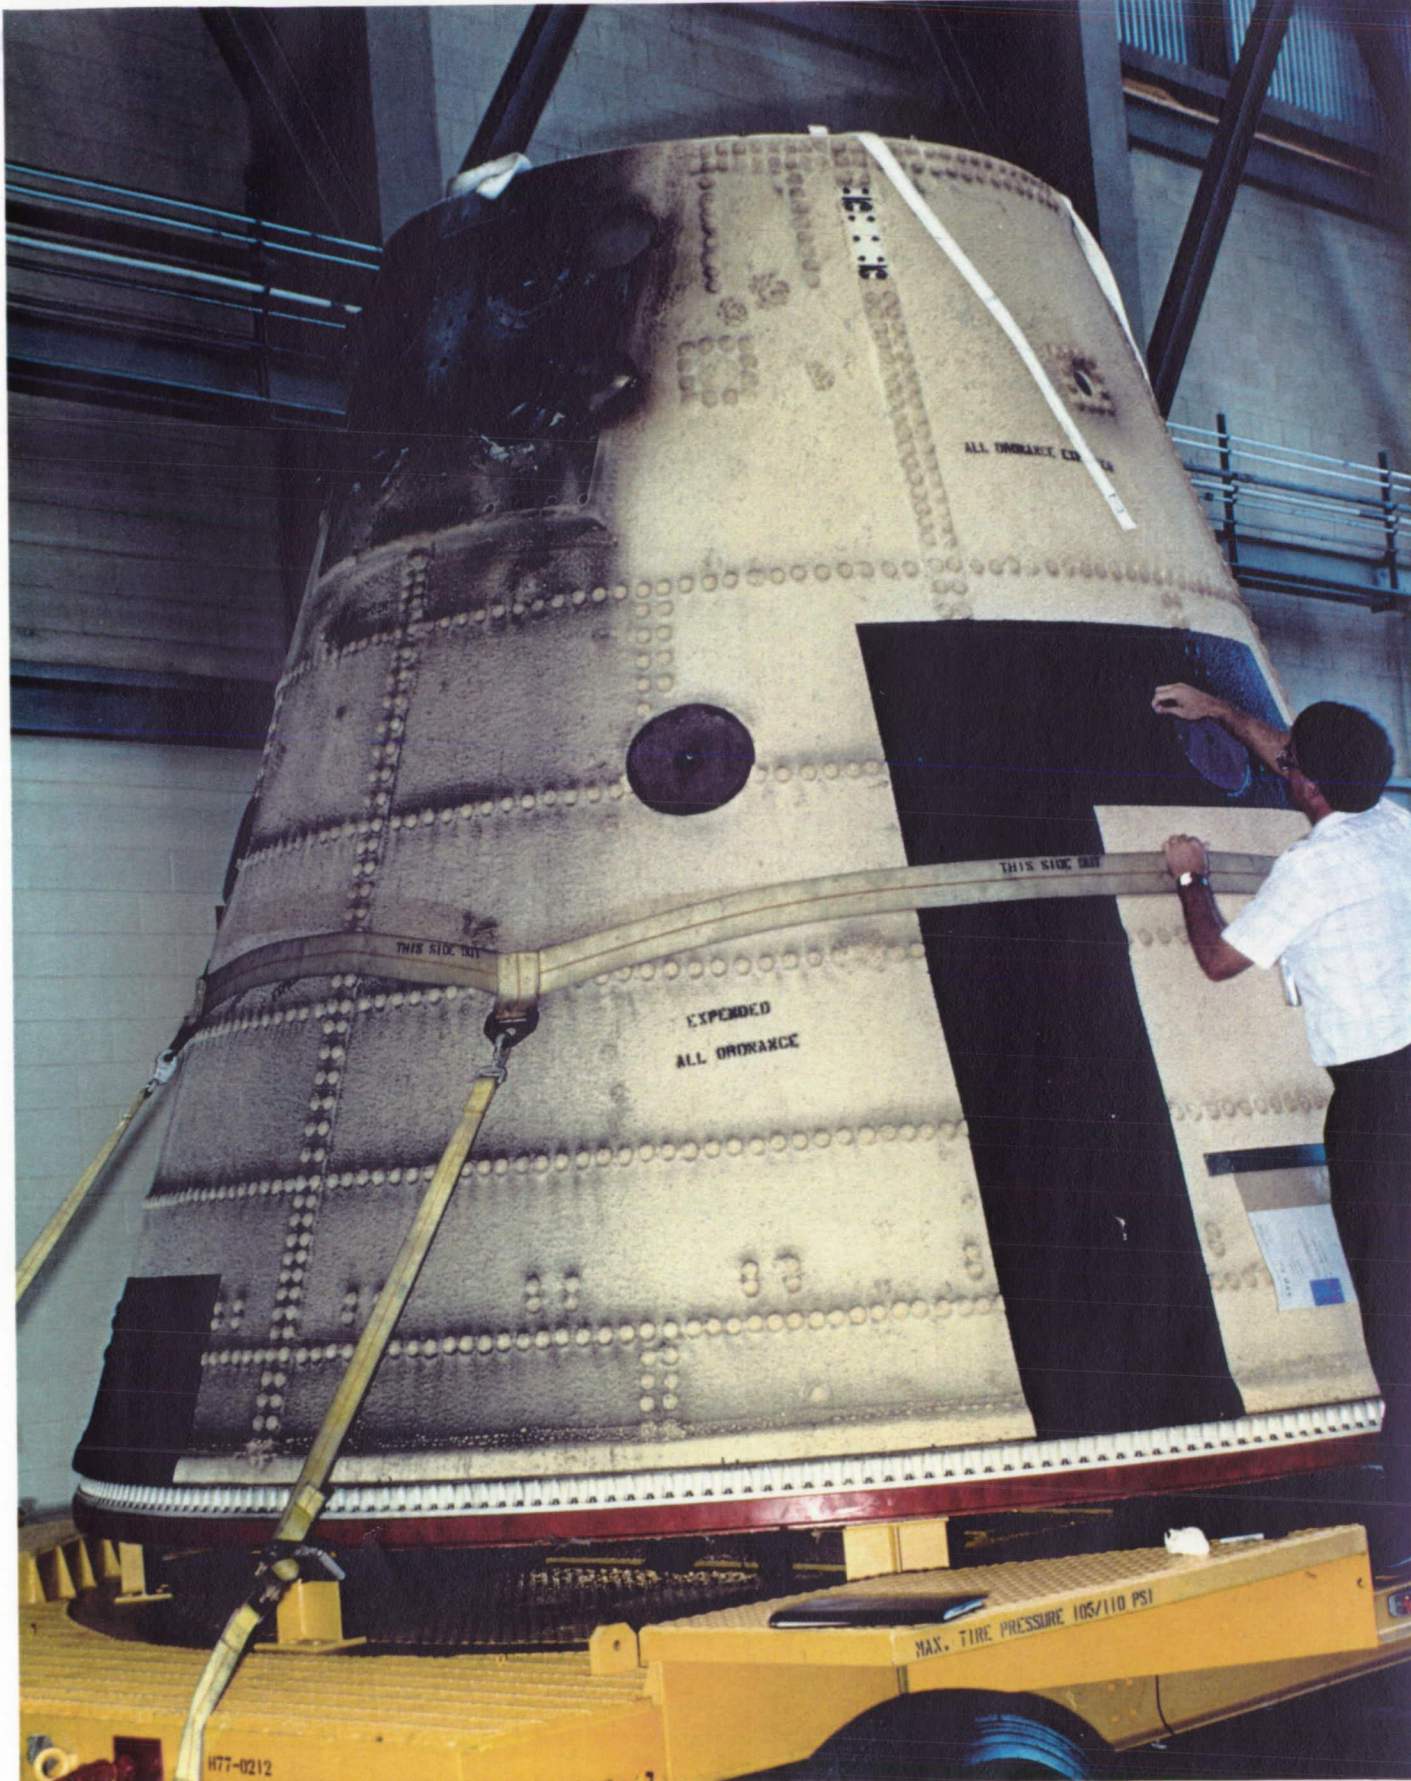
The RH frustum had 10 MSA-2 debonds over fasteners and one area of missing TPS near the 381 ring frame between the +Y and +Z axes. All BSM aero heat shield covers were locked in the fully opened position.

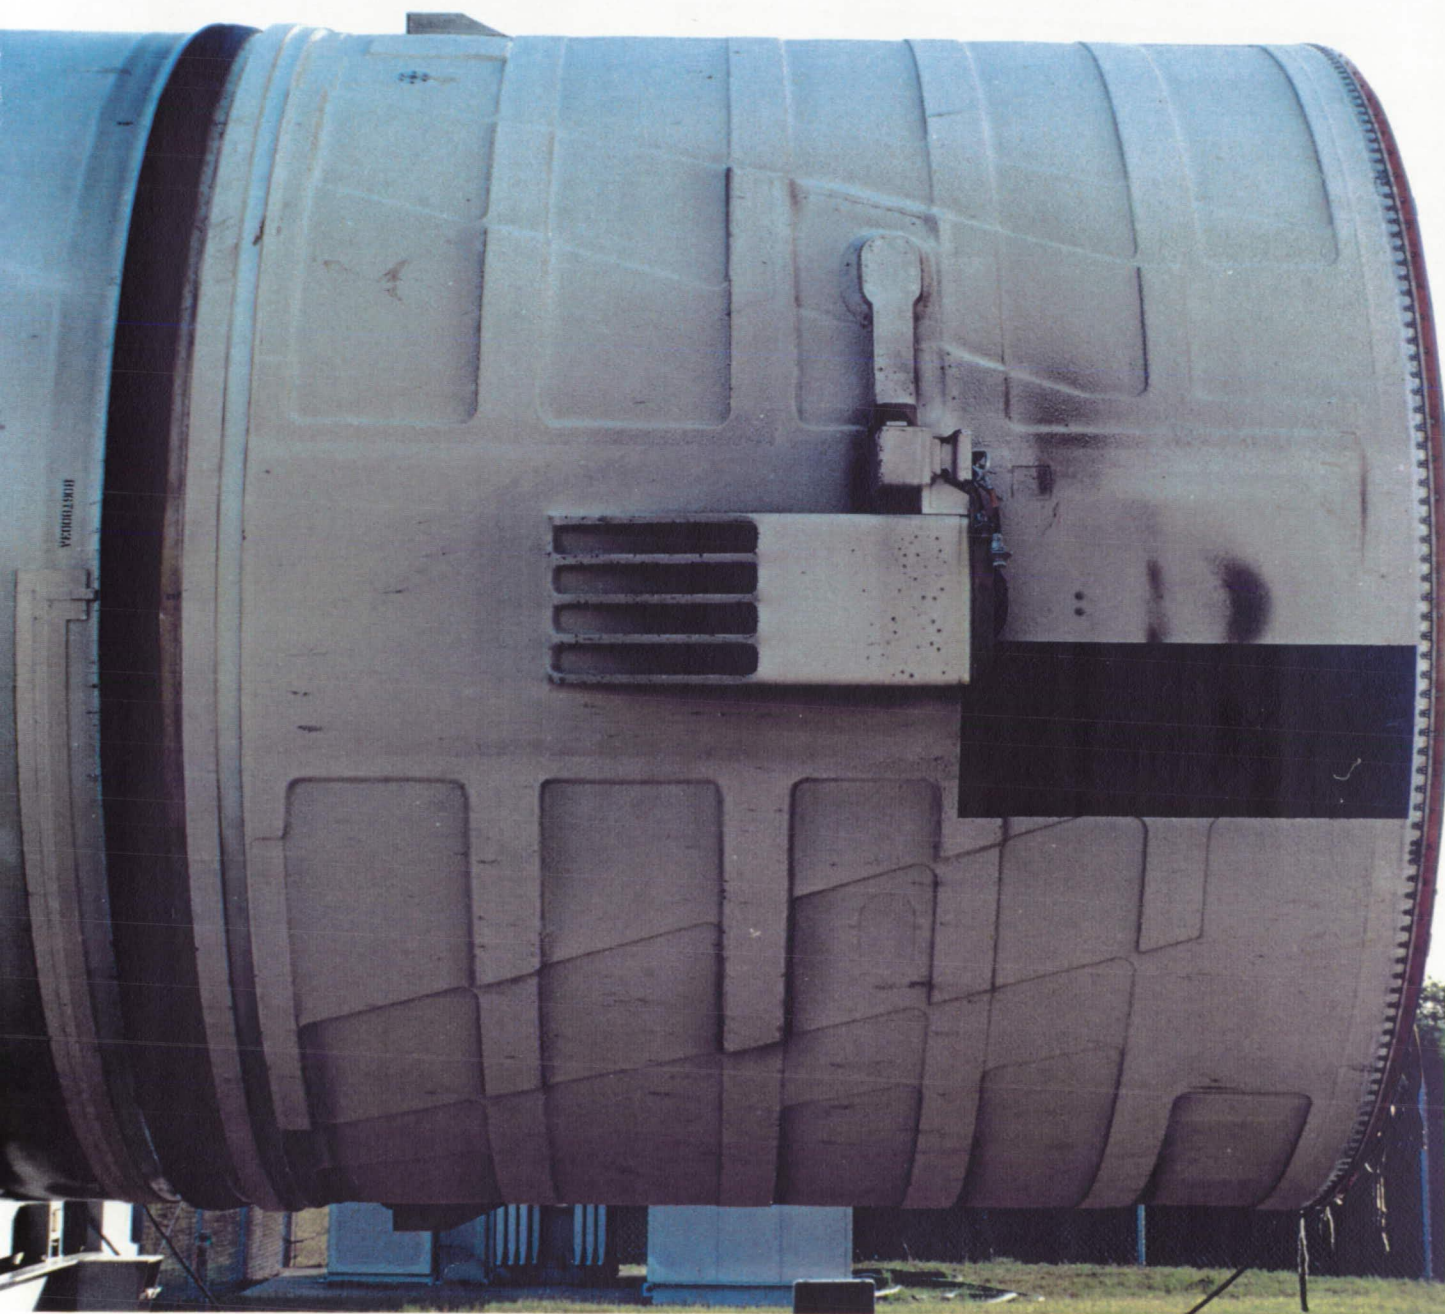
The RH forward skirt exhibited no debonds or missing TPS. Minor blistering of the Hypalon paint occurred in localized areas. Both RSS antenna covers/TPS were intact and undamaged.

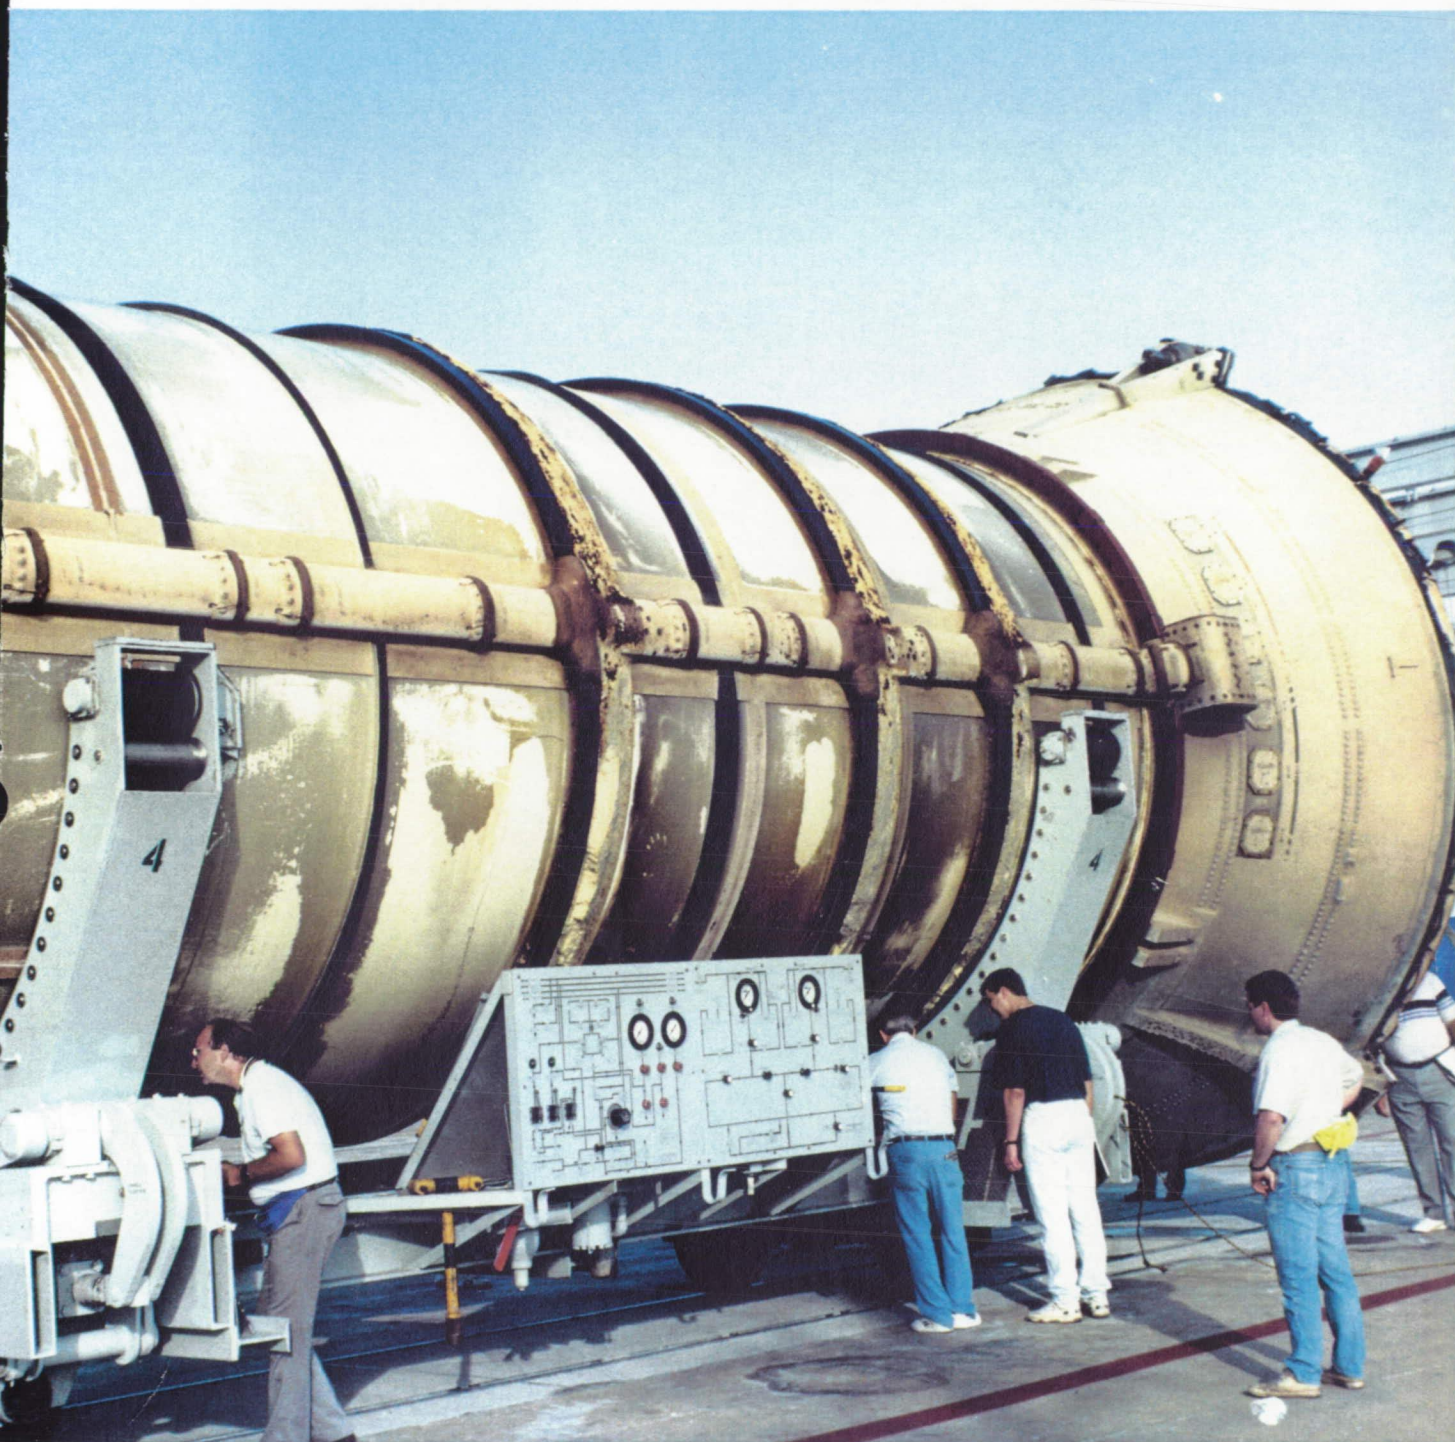
Post flight condition of the RH aft booster. The aft skirt acreage TPS was sooted but in good condition. The ET/SRB aft struts, ETA ring, and IEA appeared undamaged. All three aft booster stiffener rings sustained water impact damage.

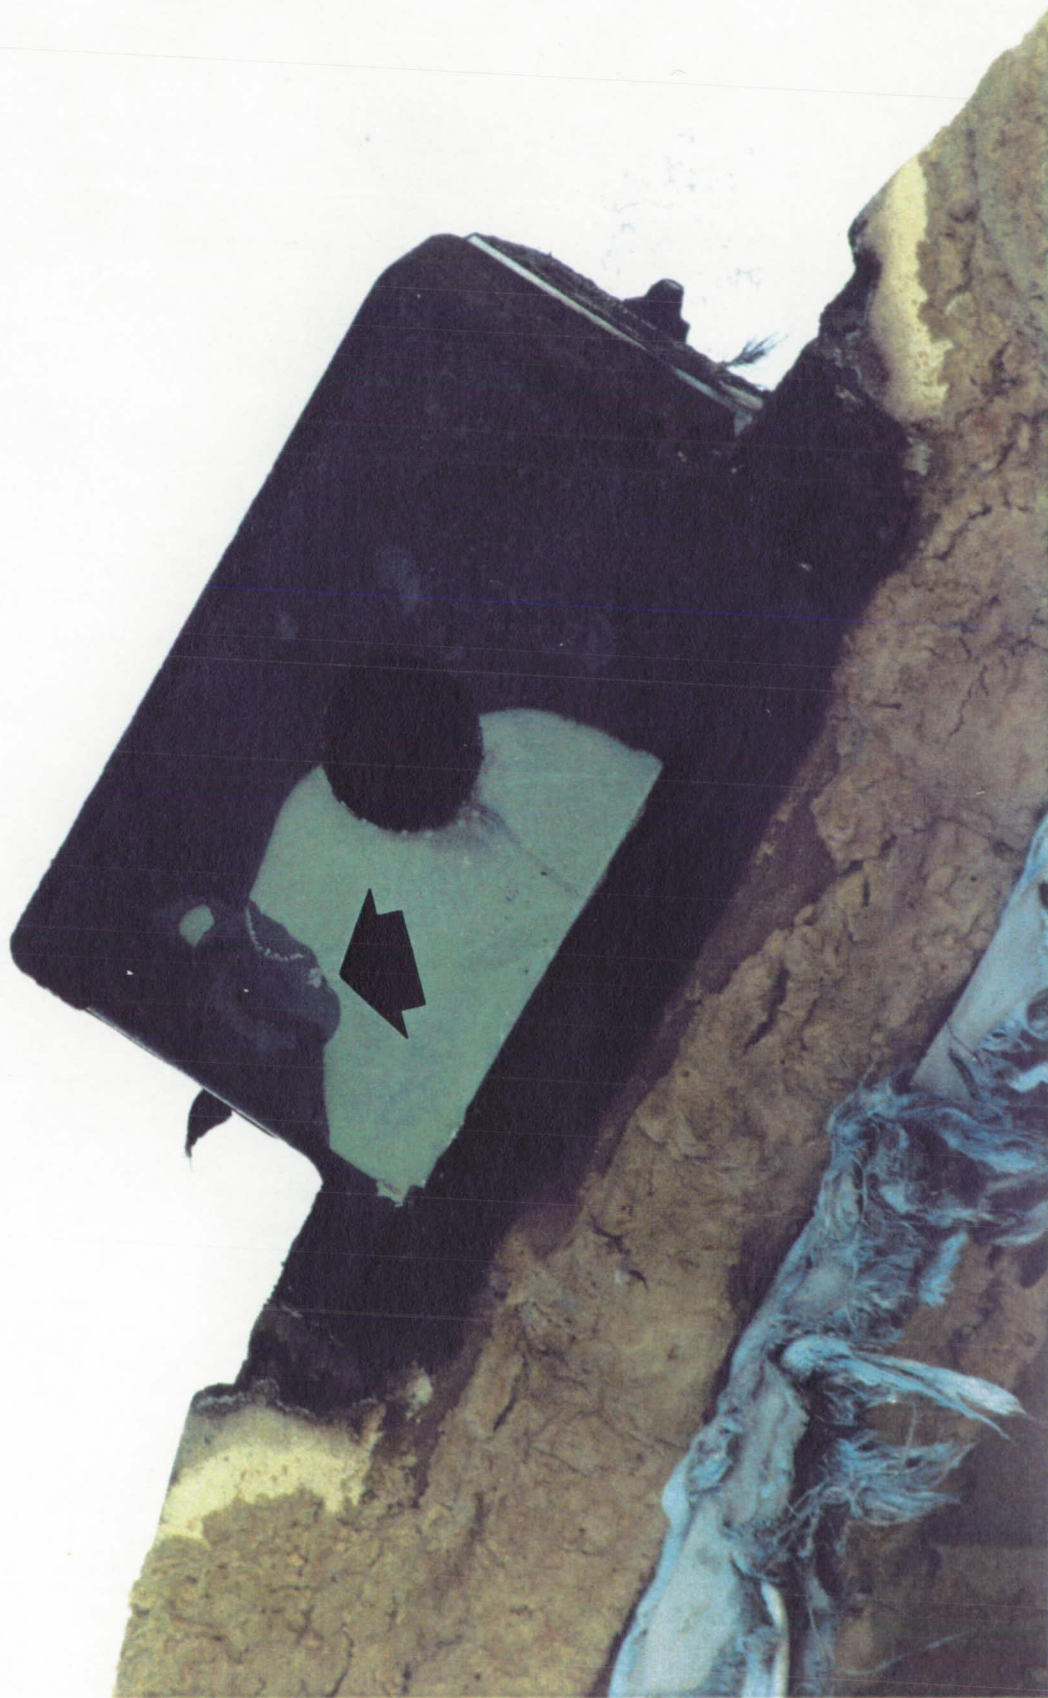
A 3-inch diameter piece of the HDP #3 EPON shim was missing prior to water impact (sooted/charred substrate).

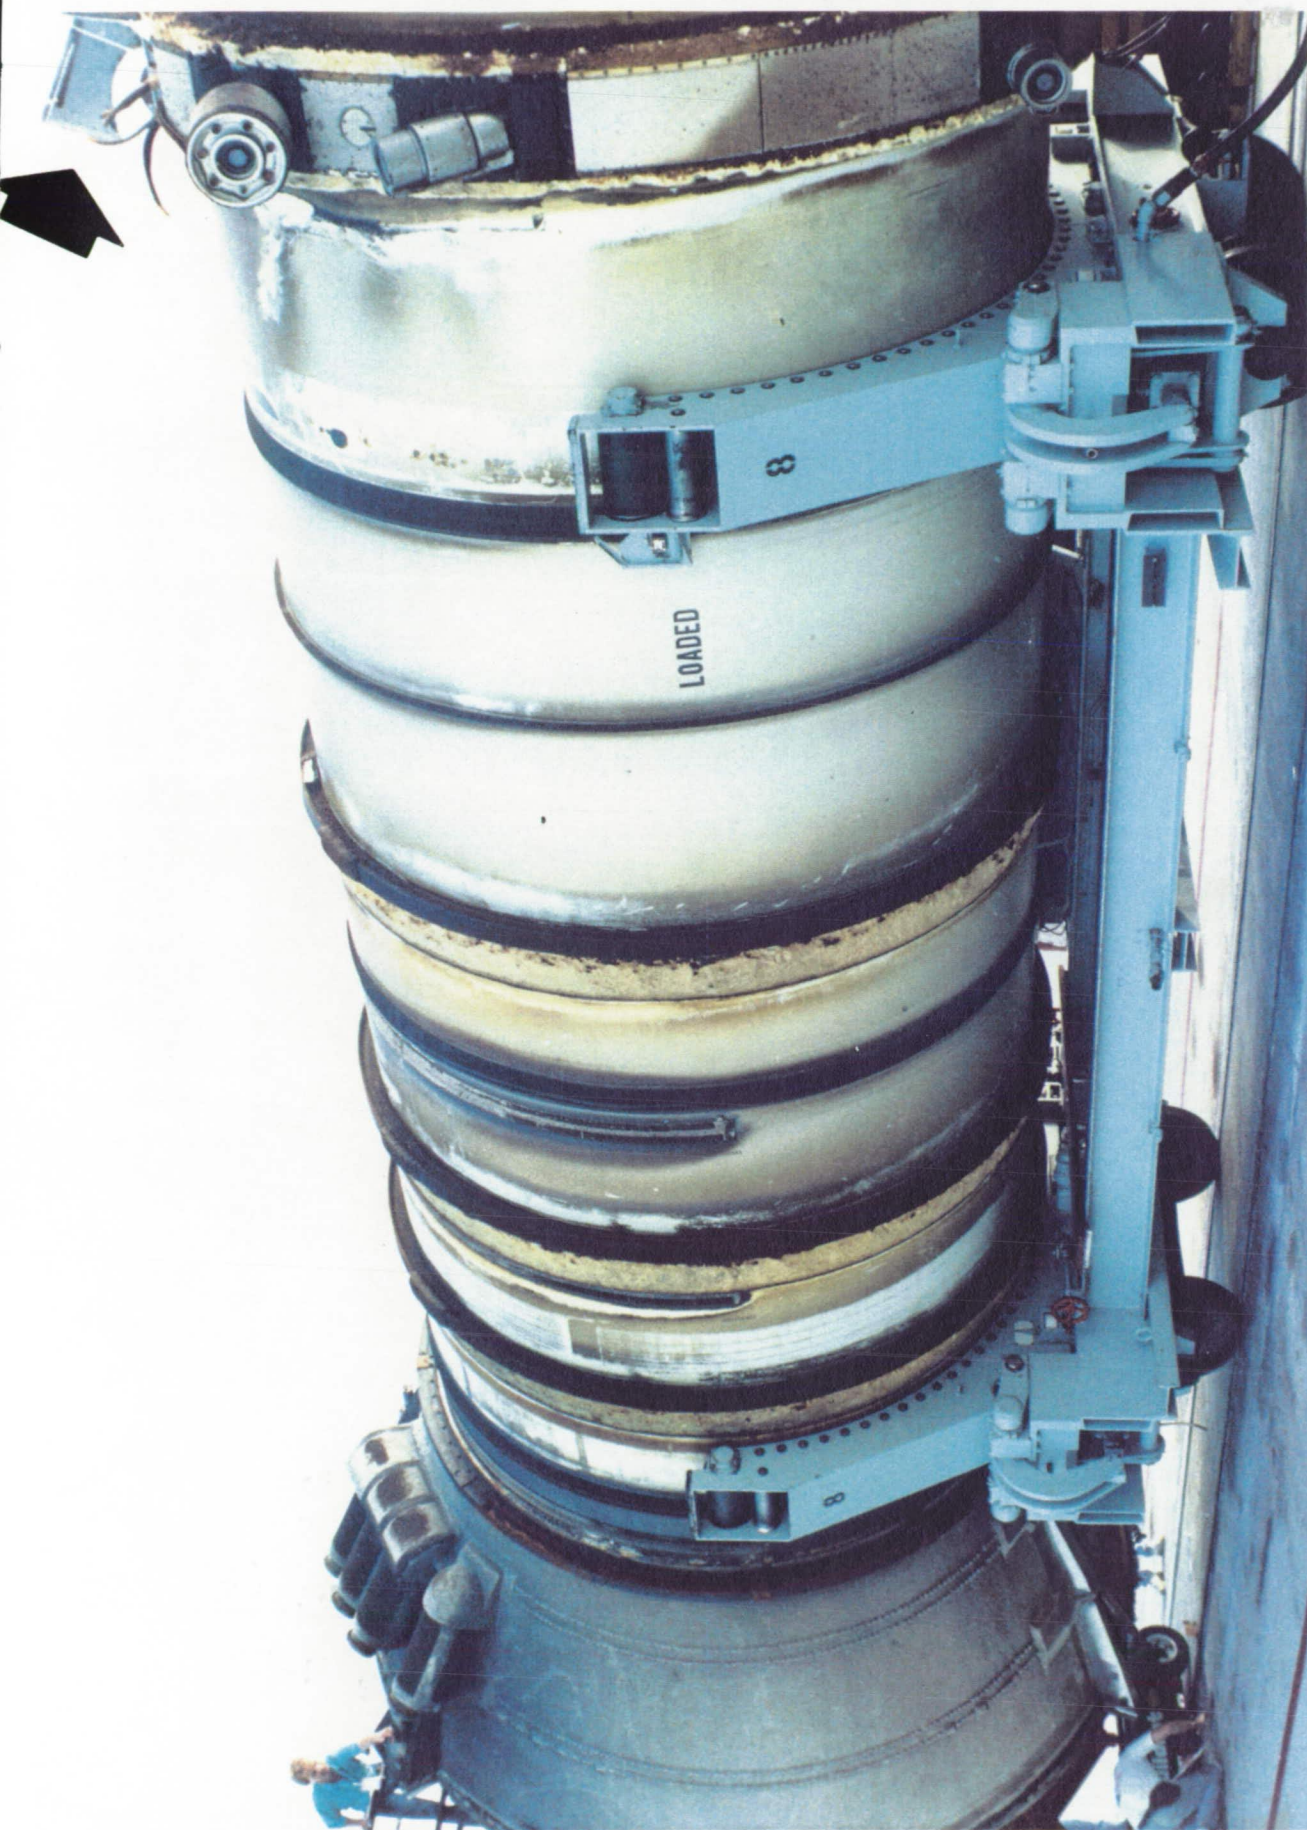
Post flight condition of the LH aft booster. The aft skirt acreage TPS was sooted but in good condition. Note water impact damage to the ETA ring and IEA.

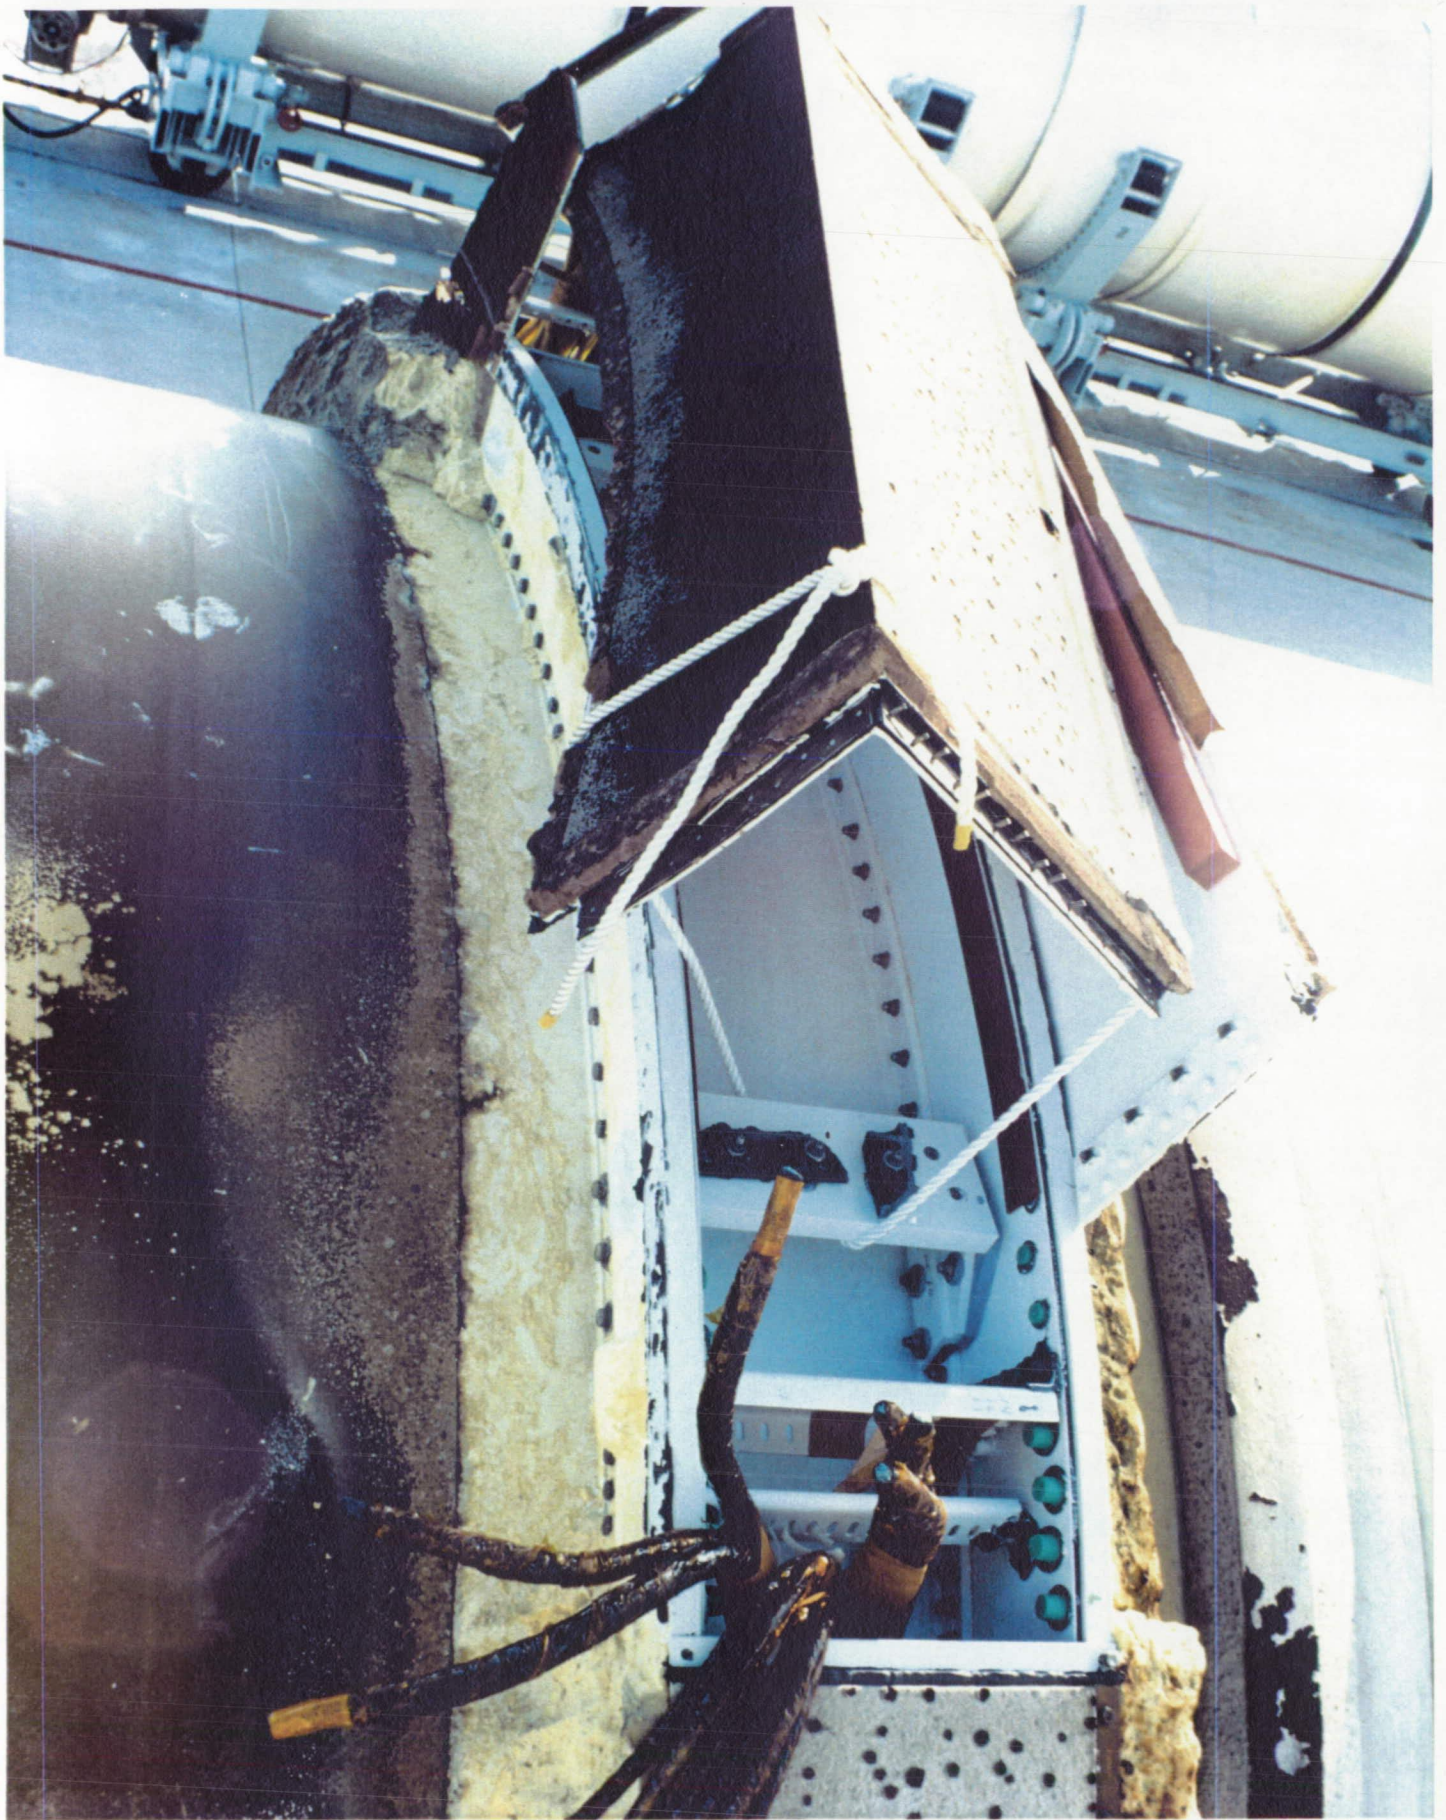
Close-in view of water impact damage to the ETA ring, IEA, and IEA covers. This type of damage was not a debris concern.

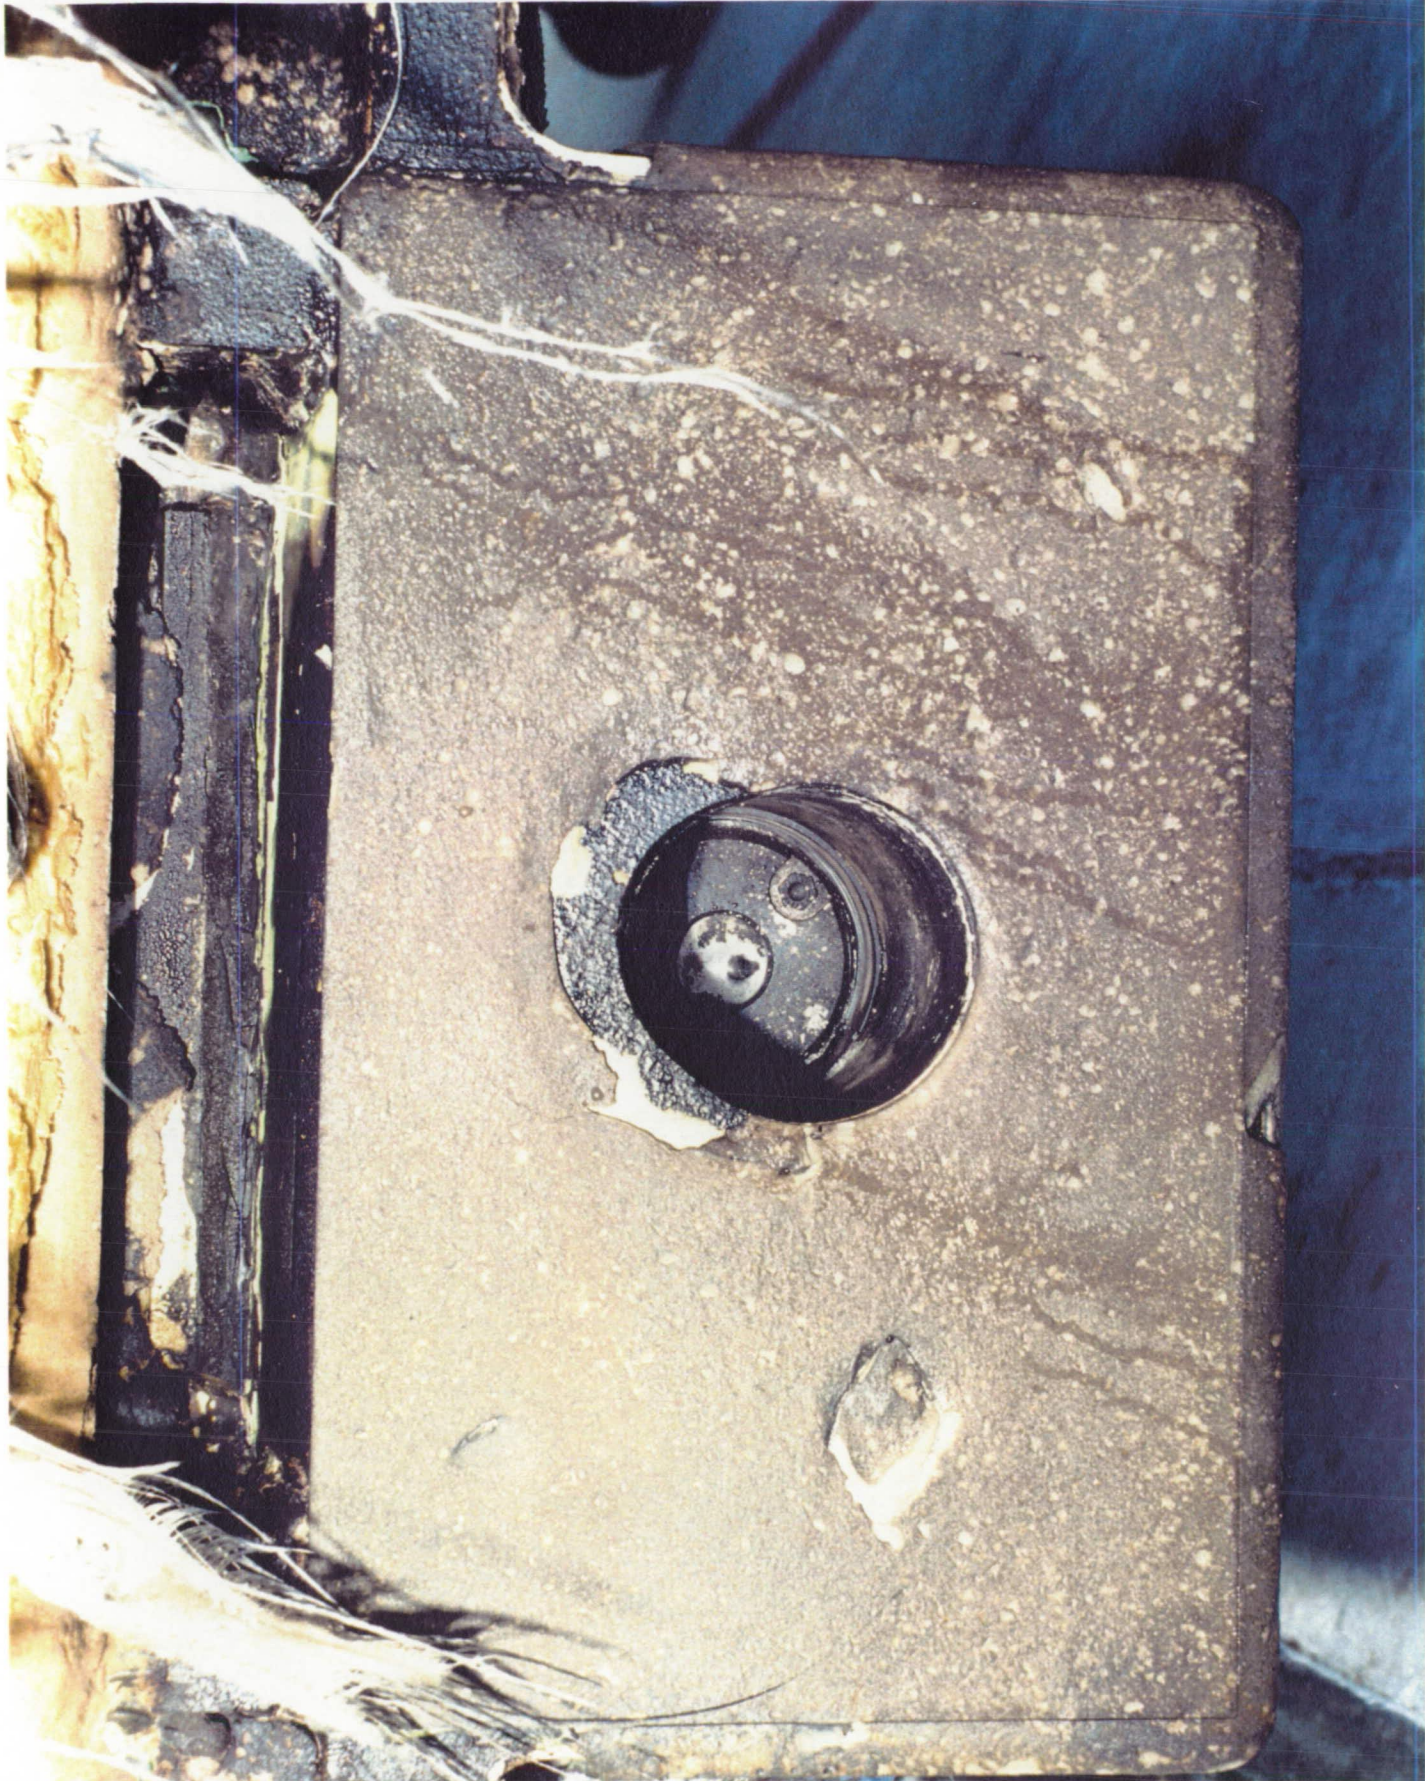
The HDP #7 stud hole was broached due to a stud hang-up at lift off as observed in the launch films. Small pieces of the EPON shim material adjacent to the stud hole had been pulled off by the stud. All four Debris Containment System (DCS) plungers were properly seated. This was the ninth flight utilizing the optimized link. None of the remaining EPON shim material was lost prior to water impact.

The HDP #7 stud hole was broached due to a stud hang-up at lift off. Small pieces of the EPON shim material adjacent to the stud hole had been pulled off by the stud.

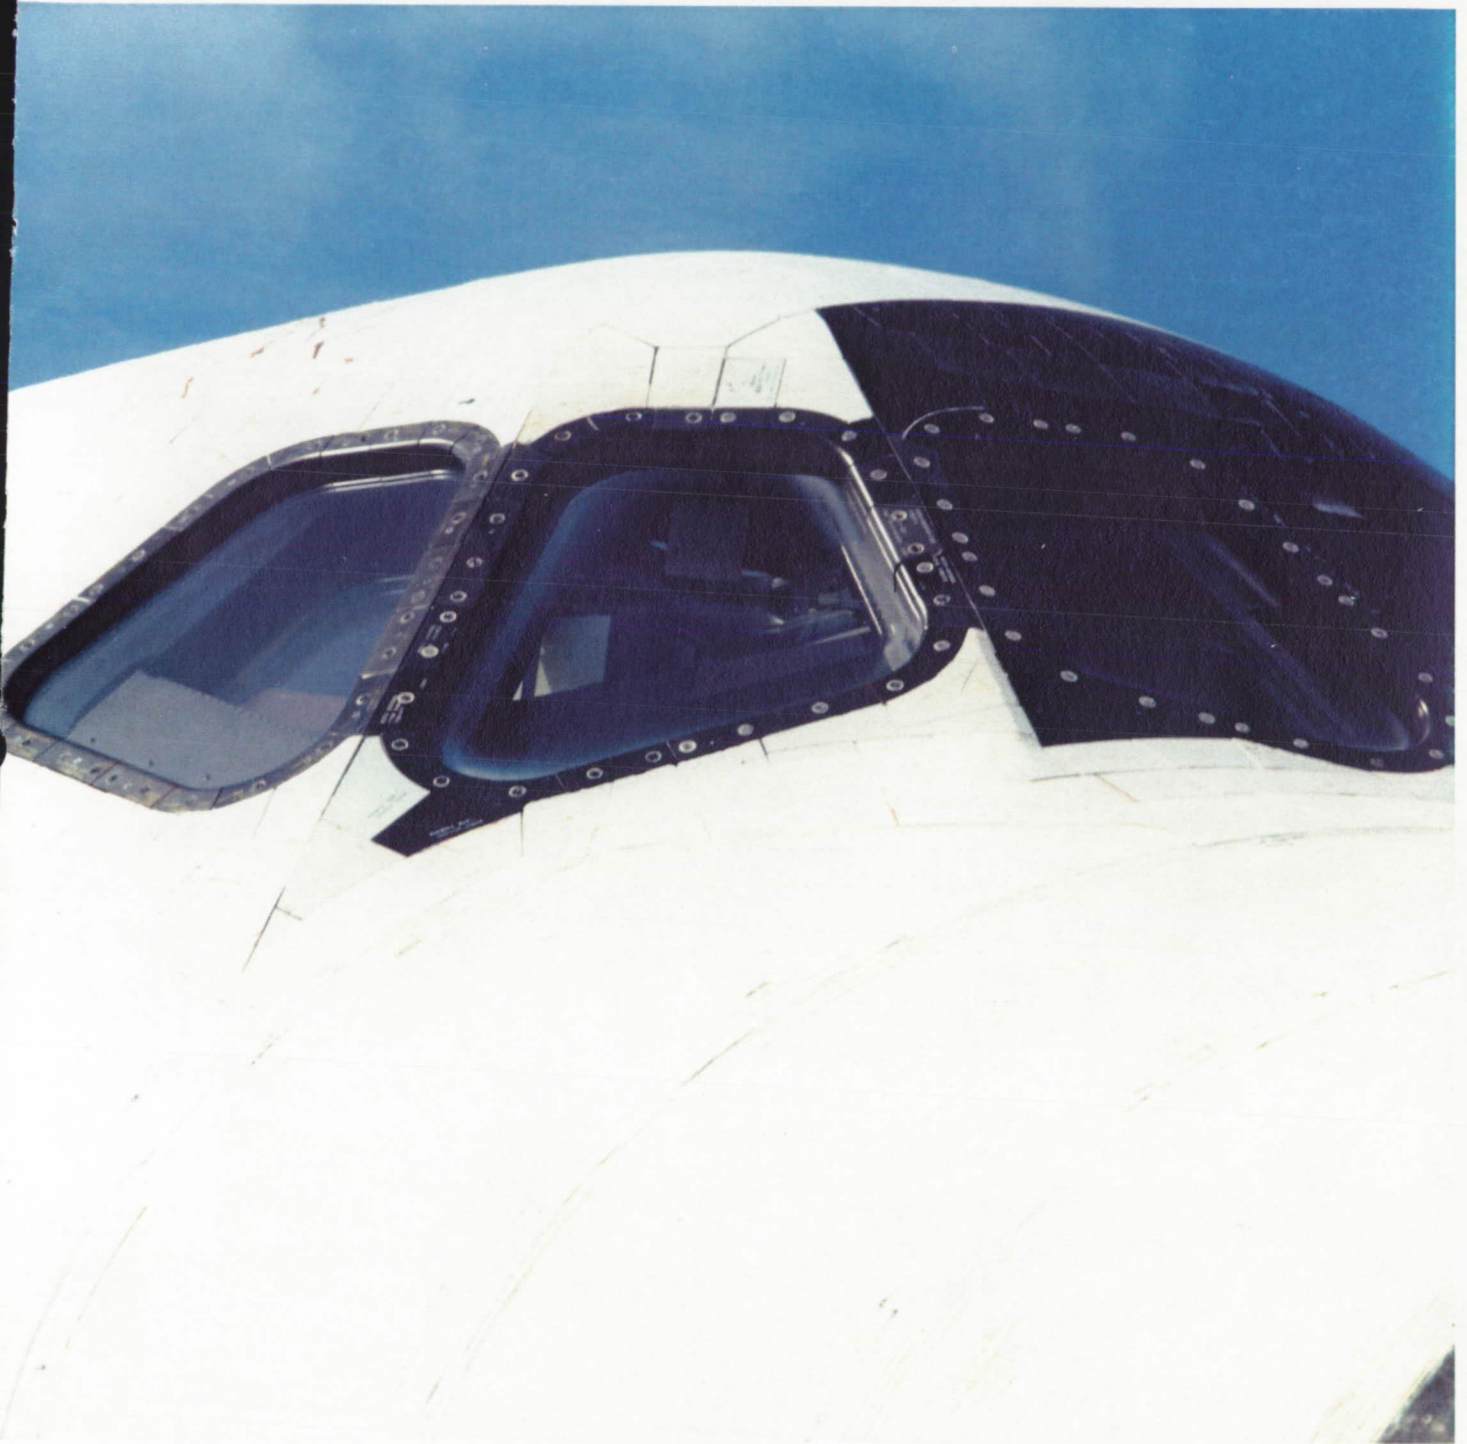
Orbiter windows #3 and #4 exhibited moderate hazing with a few streaks. Hazing on the other windows was less than usual.

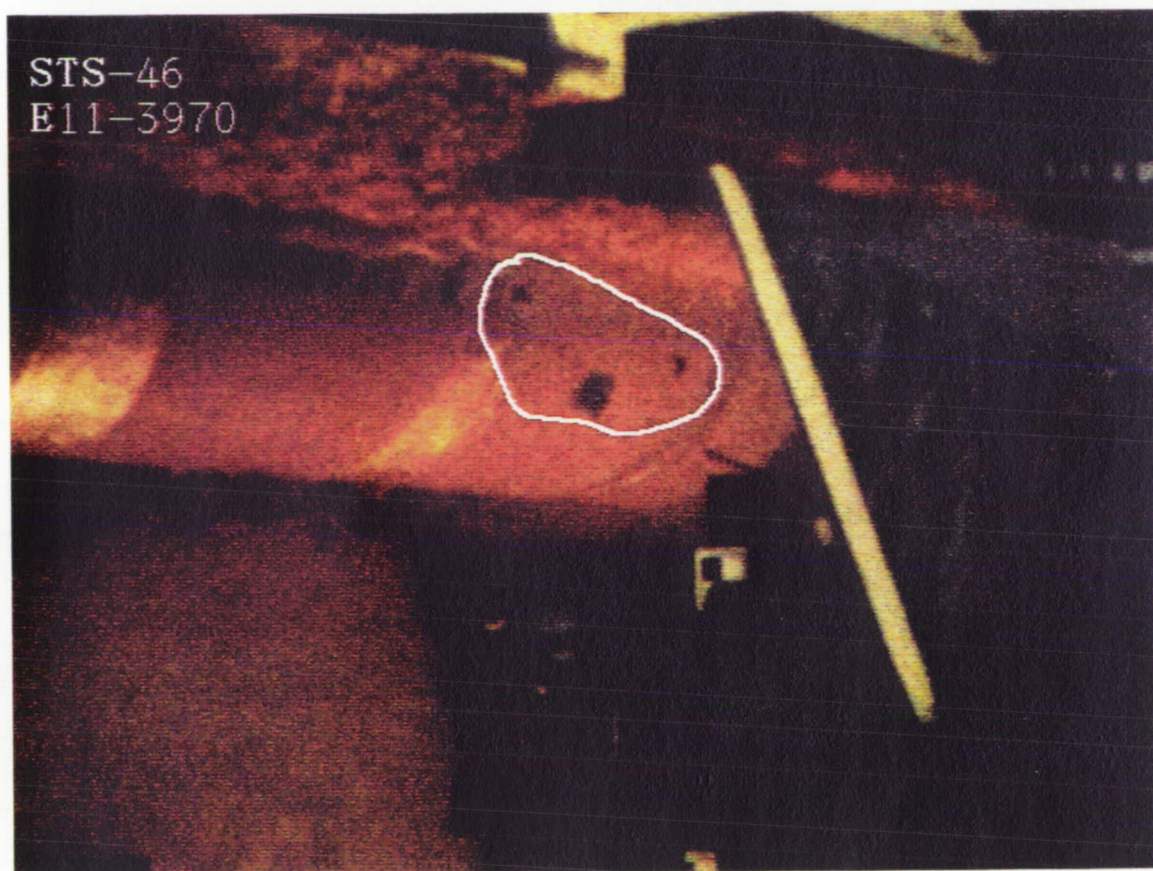
**Figure 2.1.2.2 Debris near LSRB Holddown Post M-7 at Liftoff**

Three pieces of dark debris (probably epon shim material) were noted falling from the LSRB holddown post M-7 foot at the time of the bolt hang up at liftoff (shown above).

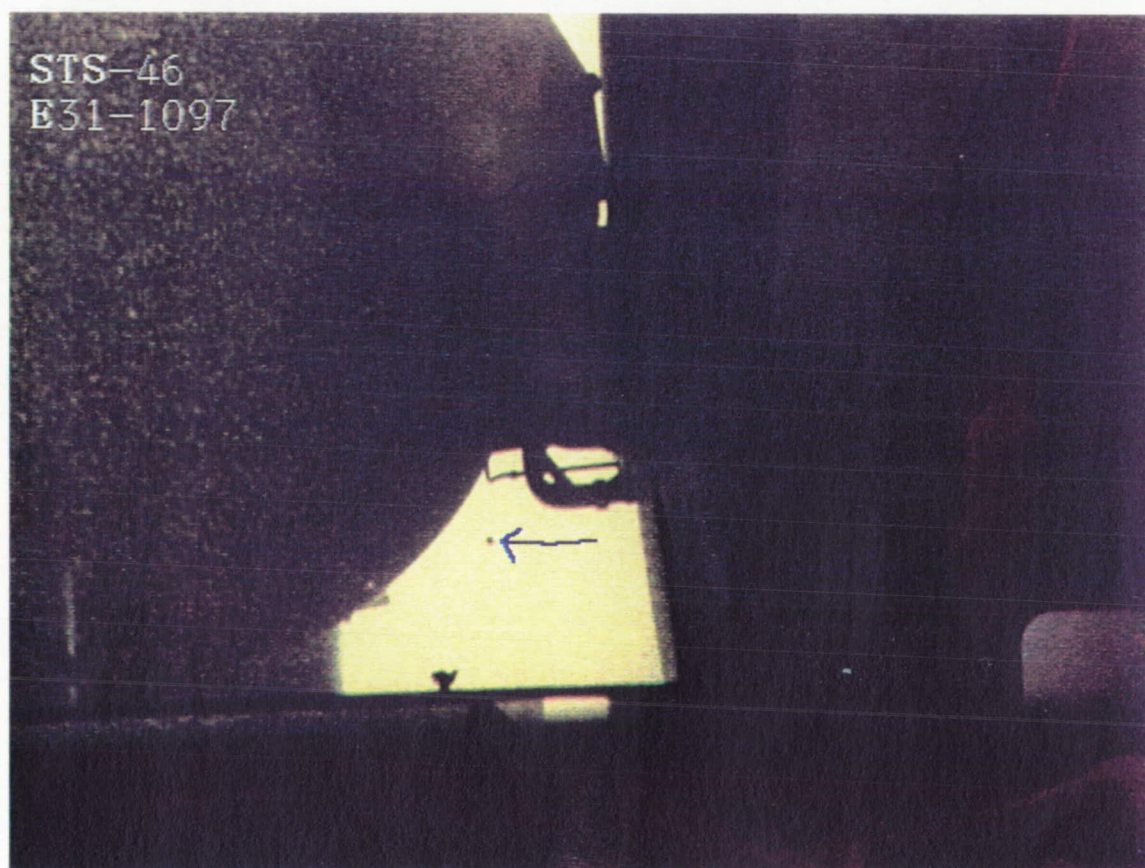
**Figure 2.1.2.5 Debris between Orbiter Fuselage and Left Inboard Elevon**

A single piece of dark debris, first seen aft of the ET aft dome and between the SRBs, traveled between the Orbiter fuselage and the left inboard elevon at liftoff. The debris did not appear to strike the vehicle.
